Northbank BID Green Infrastructure Audit

Prepared by LUC
June 2014

Client: Northbank BID

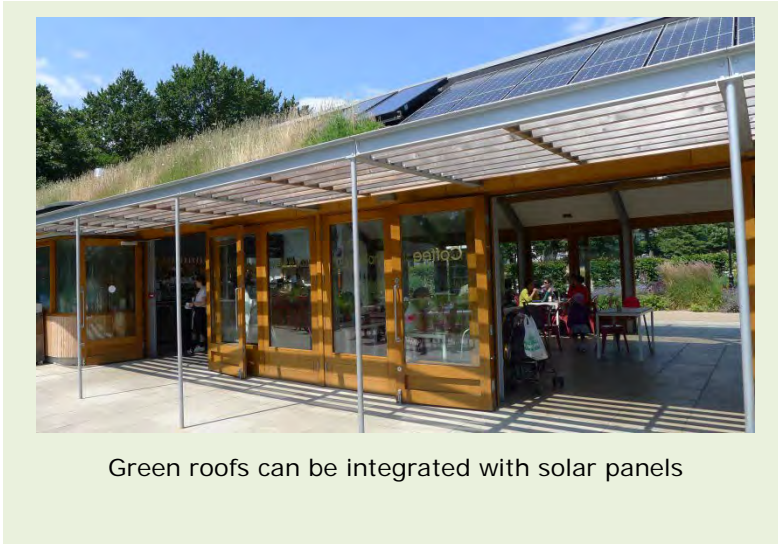
Green roofs can be integrated with solar panels

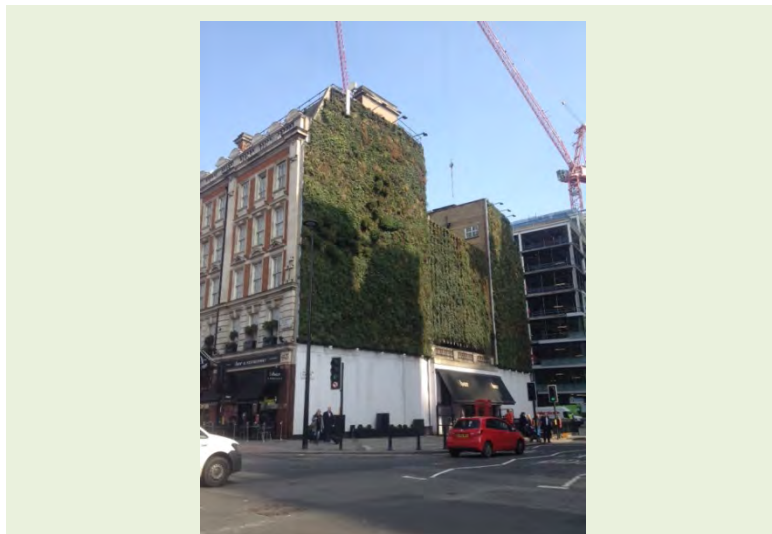
2.20 There are no green walls within the study area although situated to the south west alongside Green Park on Piccadilly there is one of the tallest green walls in London at the Athenaeum Hotel (image below).

Green walls can alleviate flood risk

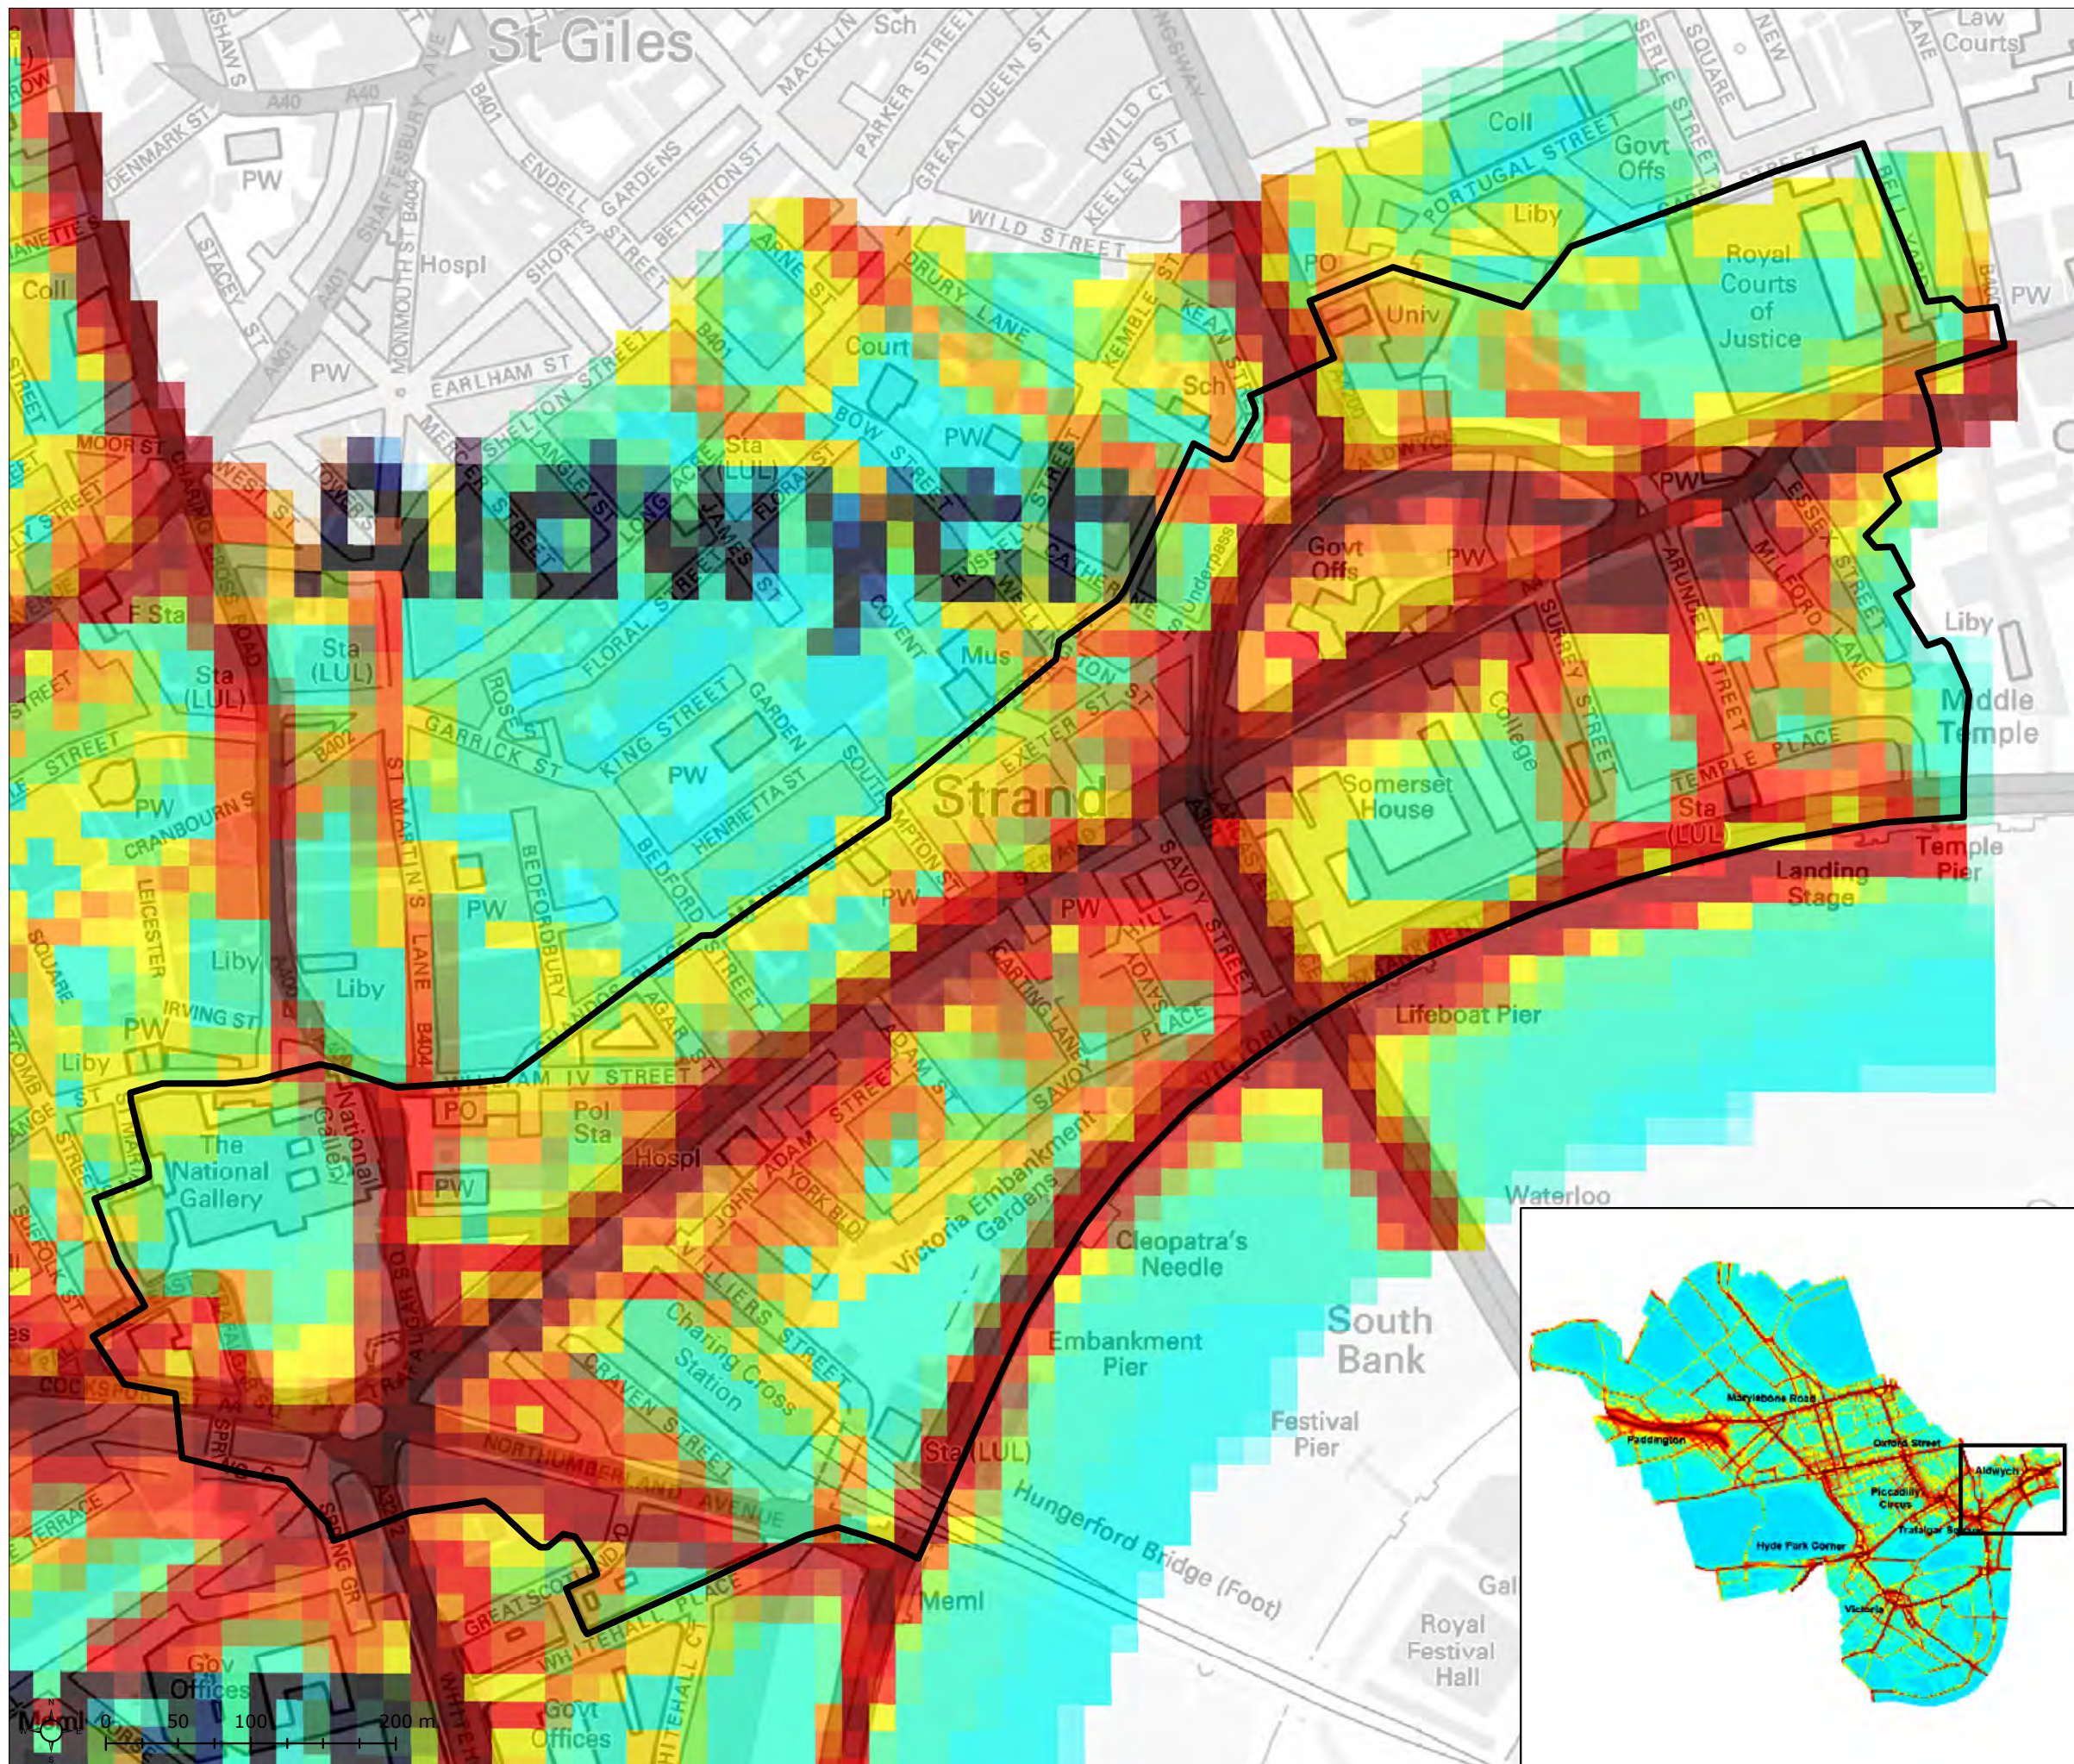
Figure 2.2

NO2 annual mean 2015

- 2.11 Parts of the study area which suffer from particularly poor air quality, are shown in **Figure 2.2: Air Quality**. Nitrogen dioxide (NO₂) is a key indicator of poorer air quality, caused mainly by traffic. It can be seen that the key transport routes including Aldwych, Kingsway, Strand, Waterloo Bridge, Northumberland Avenue and Victoria Embankment has higher annual predicted Nitrogen dioxide levels so their greening could help alleviate the concentration of pollutants in the air.

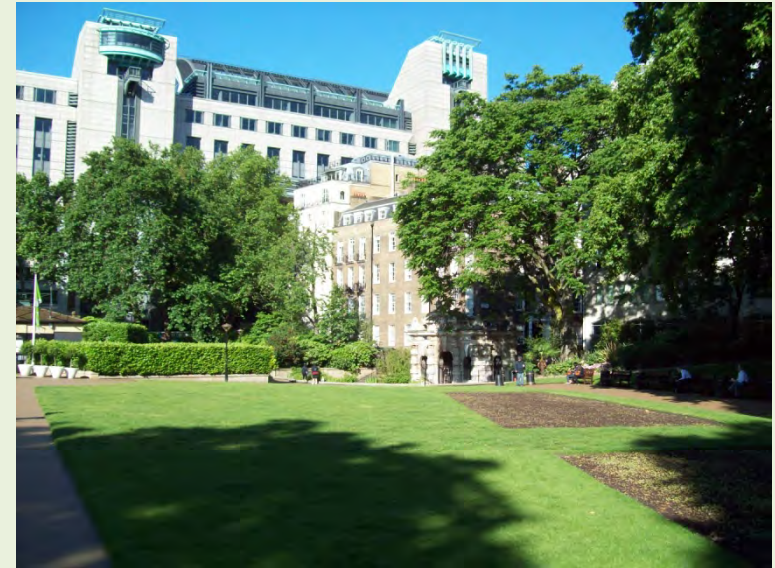
A view across the formal lawns towards Charing Cross Station and the York House Water Gate

- 3.11 The proposed café extension and refurbishment could provide further opportunity for small scale greening in terms of planters and green trellis/screening for visual improvement. An image of the open formal park in 2014 is shown below and suitable plant species which could complement its historic design and benefit wildlife follow.

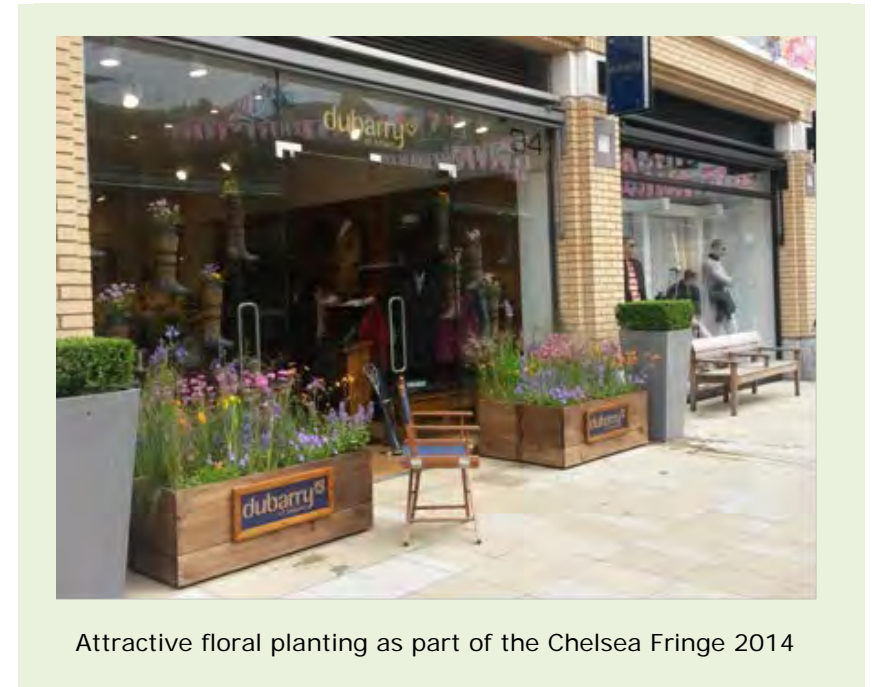
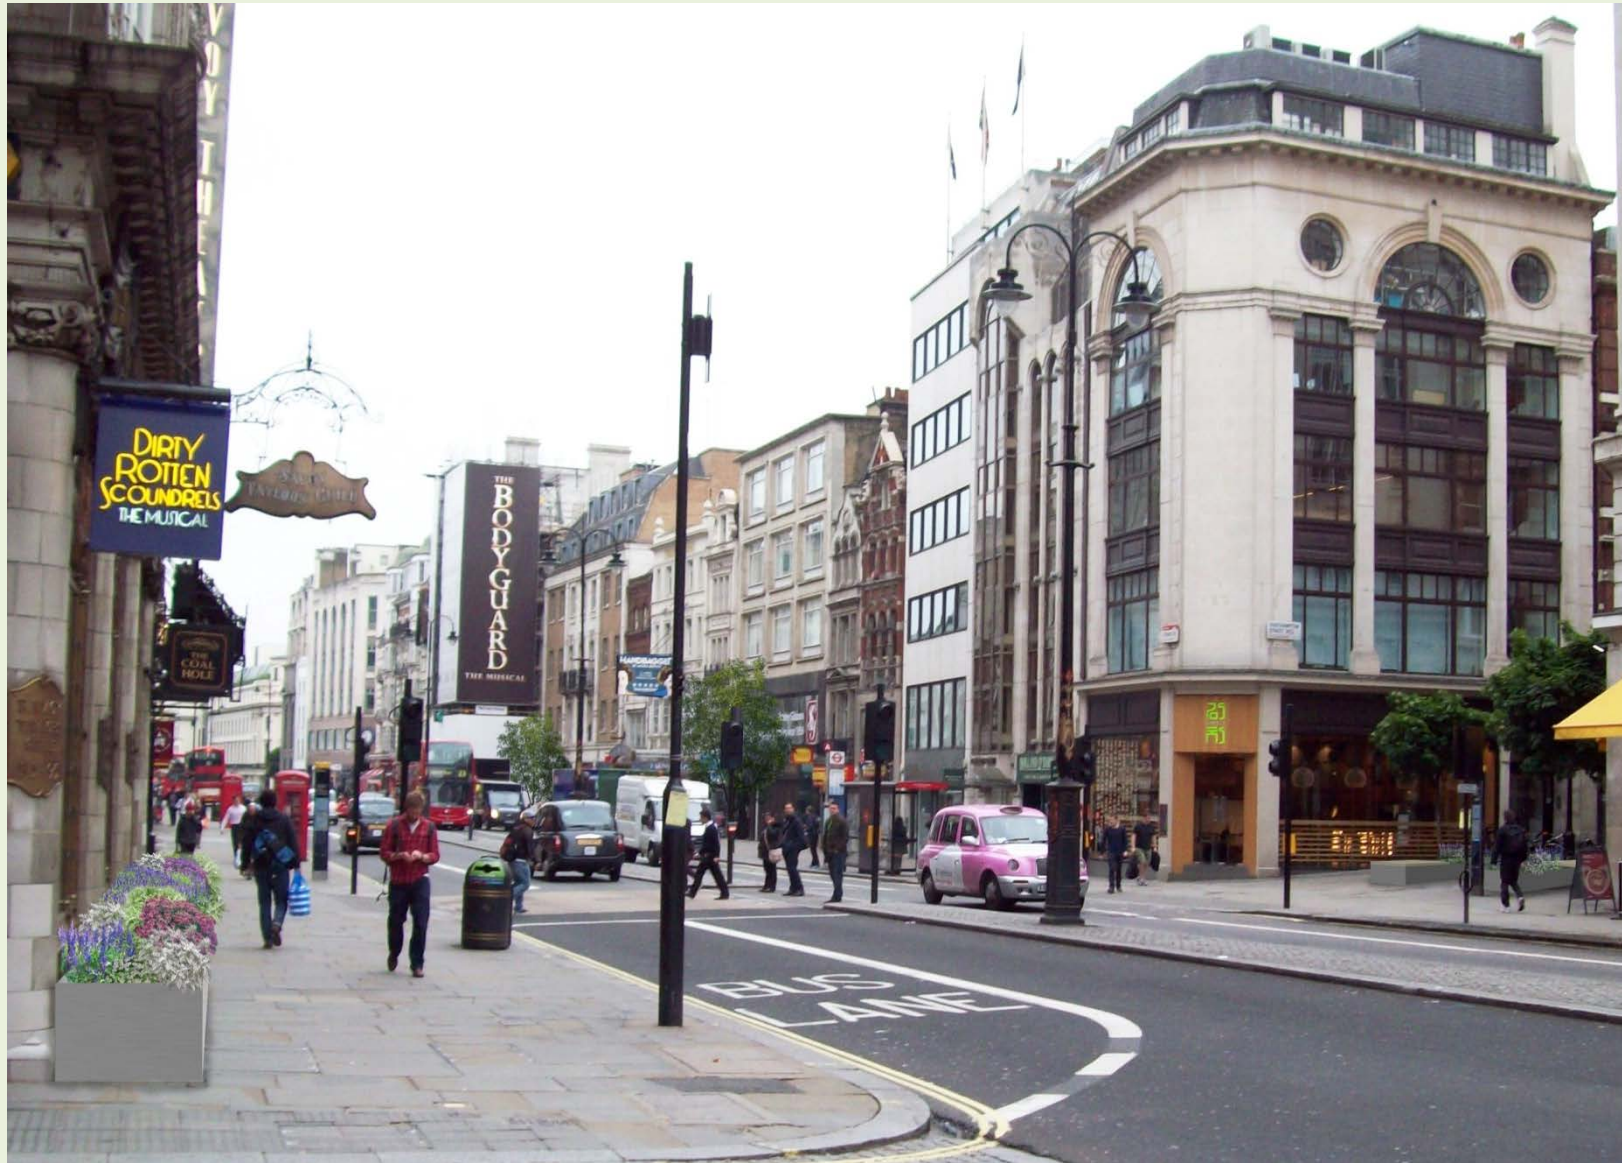
Planters with a consistent colour palette could be installed by businesses along Strand, as well as new trees.

- Planters could be utilised adjacent to shop and building fronts in a proposed consistent palette of Northbank 'blue', white and silver with seasonal interest through bedding plants. These would not obstruct free flow of pedestrian movement and would be located in appropriate wider sections of footway to enhance the visual appeal and attract pollinators.

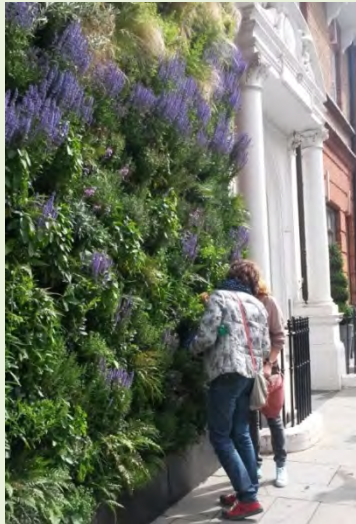
Attractive green wall created for the Chelsea Fringe 2014

3.35 The most economical way of achieving a green wall is with climbing plants, which could cost approximately £50 per m²; whilst the alternative is to install a 'modular green wall', where plug plants are established within a vertical growing system. The latter is a more expensive option with a more immediate effect, and costs approximately £400 per m². Important considerations when planning green walls are the aspect (north-facing walls need less maintenance and use less water than south-facing walls) and having a nearby water source, preferably harvested greywater or rainwater. For modular systems it is important to confirm with a structural engineer that the wall can support the weight and take any necessary fixings.

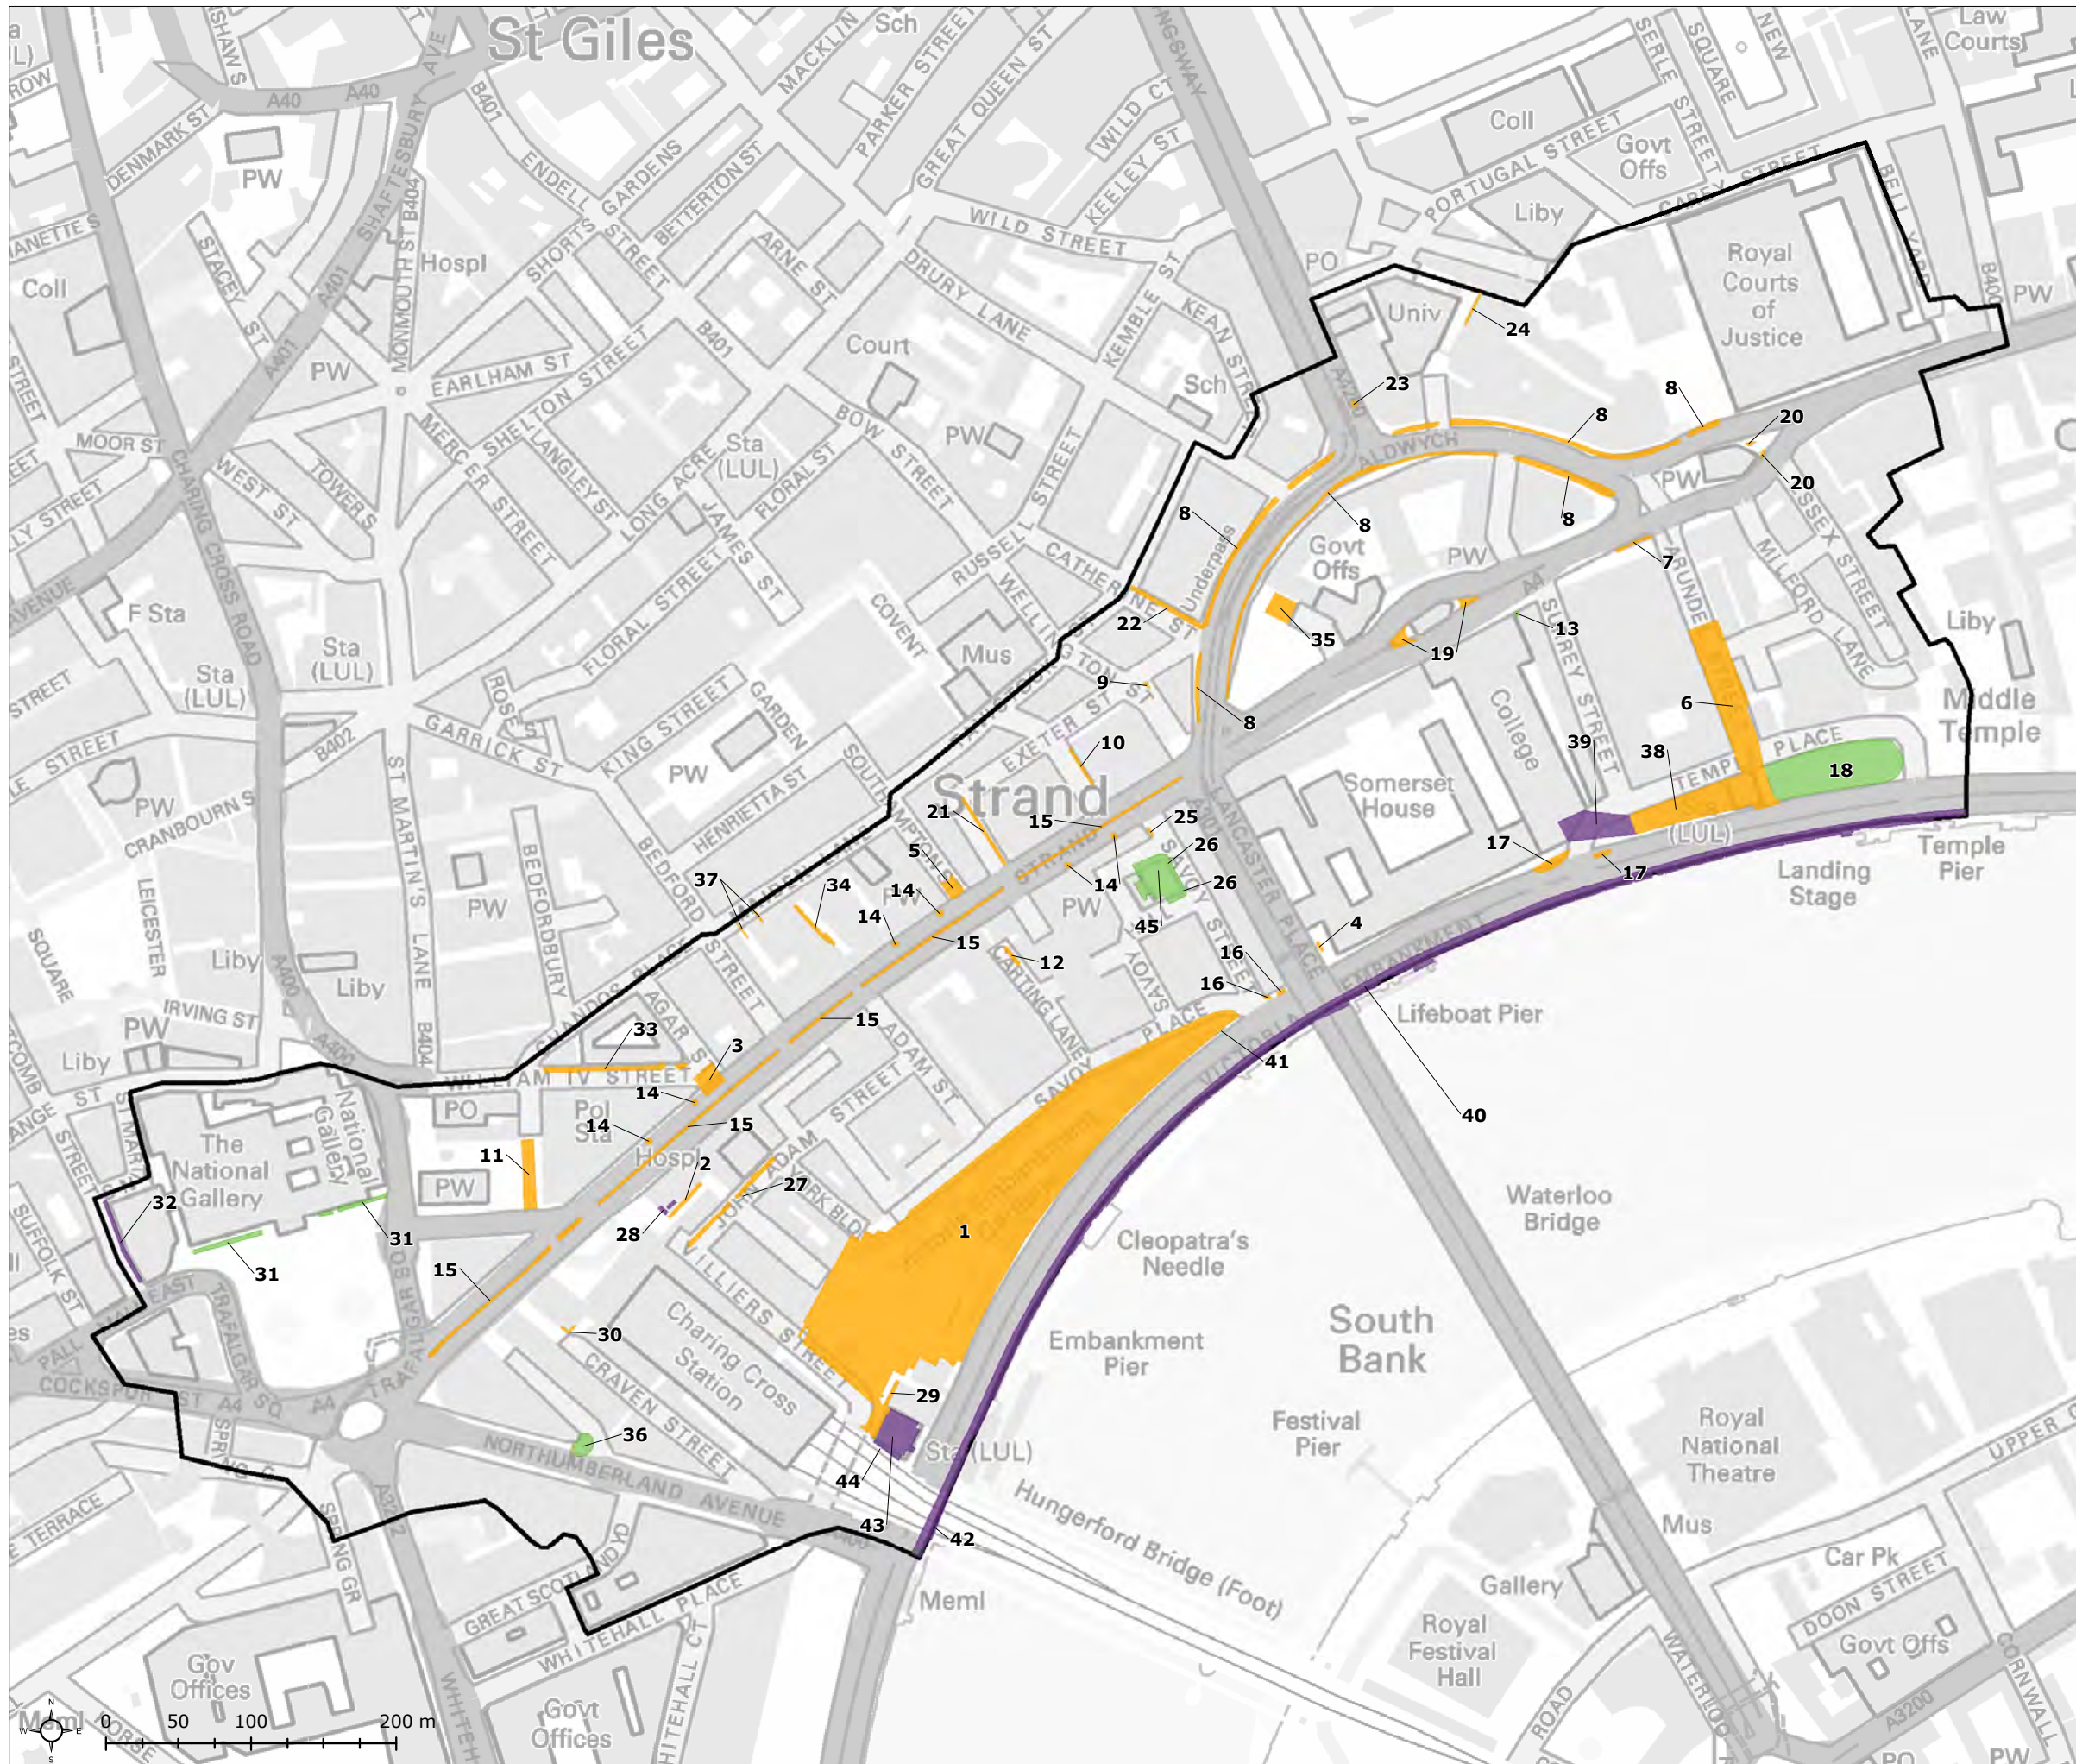
Figure 3.2

Northbank Green Infrastructure Audit

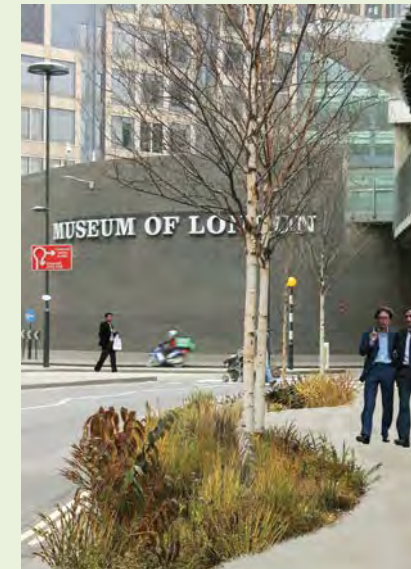
Visualisation of a roadside swale or rain garden

- Where possible, incorporate natural water storage areas, such as swales/rain gardens, ponds and ditches within the urban context (image below).

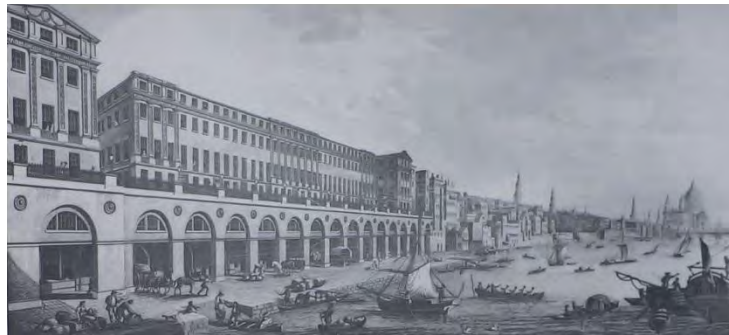
Above: The Adam Brothers' monumental Adelphi built from 1768-72 on the ruins of Durham House. This view before construction of Bazalgette's Embankment shows the contrast between the elegant townhouses and the workmanlike wharves and vaults below. Mostly demolished in 1937, although some parts still survive

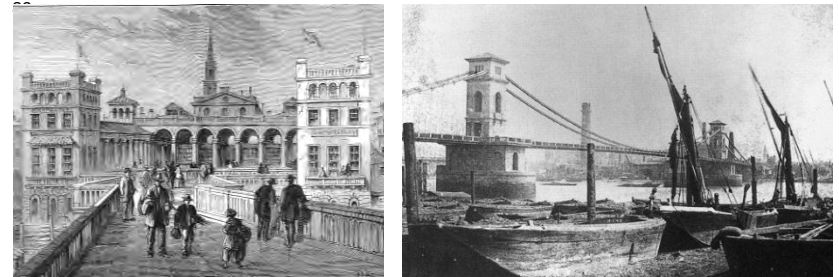
Above left: Hungerford market, c1850, approached from Hungerford Bridge
Above right: Brunel's Hungerford Footbridge. Built in 1845 and replaced by the Charing Cross Railway Bridge in the 1860s, using the same buttresses.

- 3.19 The 19th century bridge foundations including the original brick pile buttresses of Brunel's footbridge are still in use, and are an important historical asset within the Northbank area. The site forms a key gateway to the area which currently suffers from poor air quality.

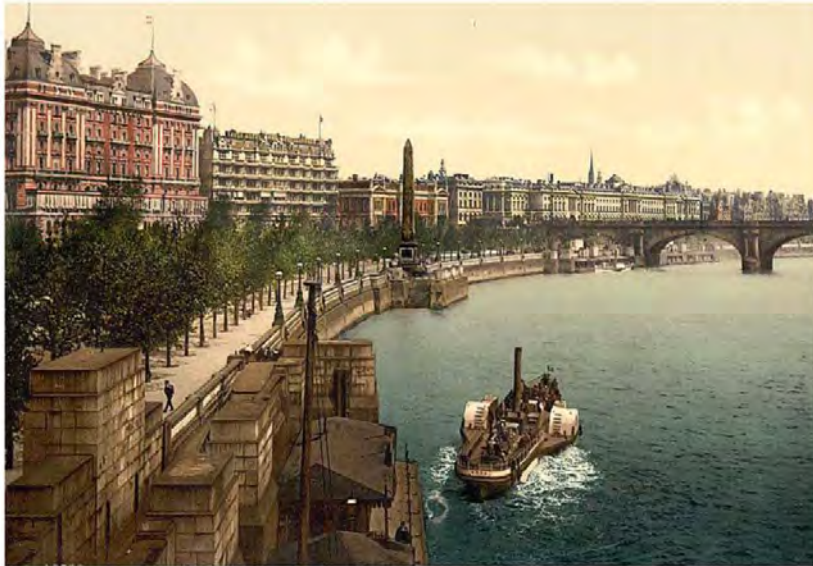
Above: The Embankment, c.1911, showing in the middle distance Rennie's fine Waterloo Bridge of 1817 and Somerset House beyond

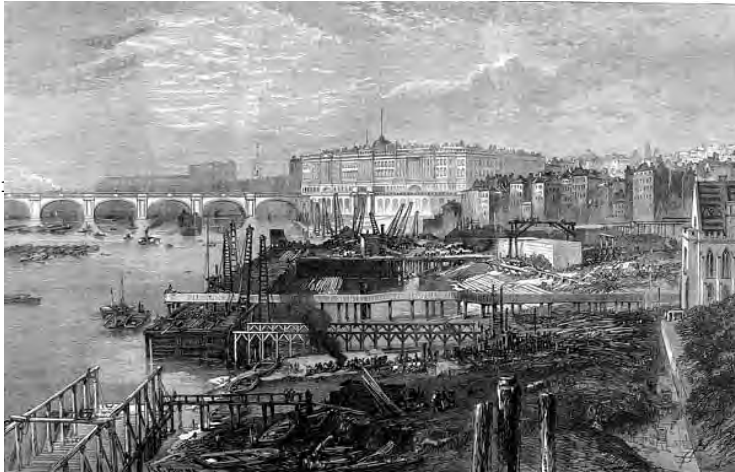
Above: Bazalgette's Embankment under construction in the 1870s. Below: Schematic section through the Embankment, showing cut and cover tube line and sewer locations, reclaimed from the river

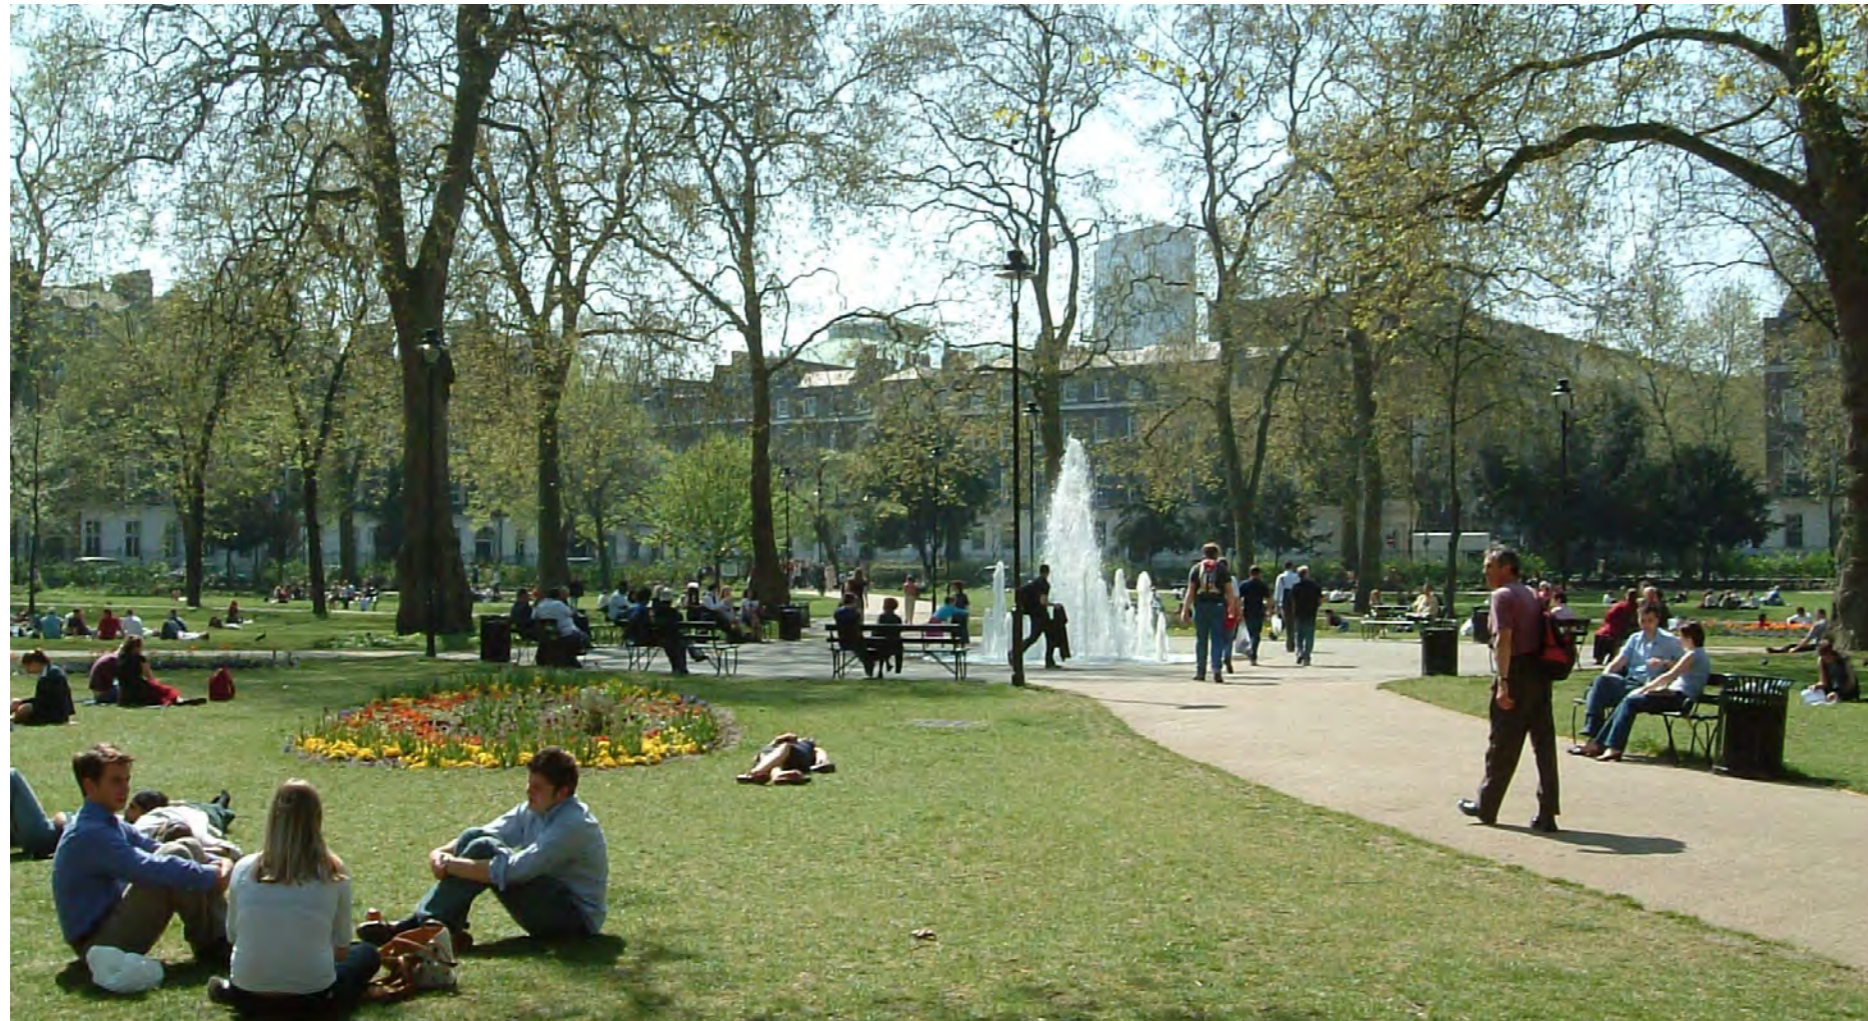
Prior to its restoration Russell Square was a lack-lustre garden square in poor condition that was attracting serious anti-social behaviour, especially after dark.

Set in the heart of Bloomsbury the square was originally designed by Humphry Repton in 1801 for the 5th Duke of Bedford. Today the square is Grade II listed and included on the English Heritage Register of Historic Parks & Gardens.

elegant jet fountain replaces the 1950s water feature and animates the centre of the square.

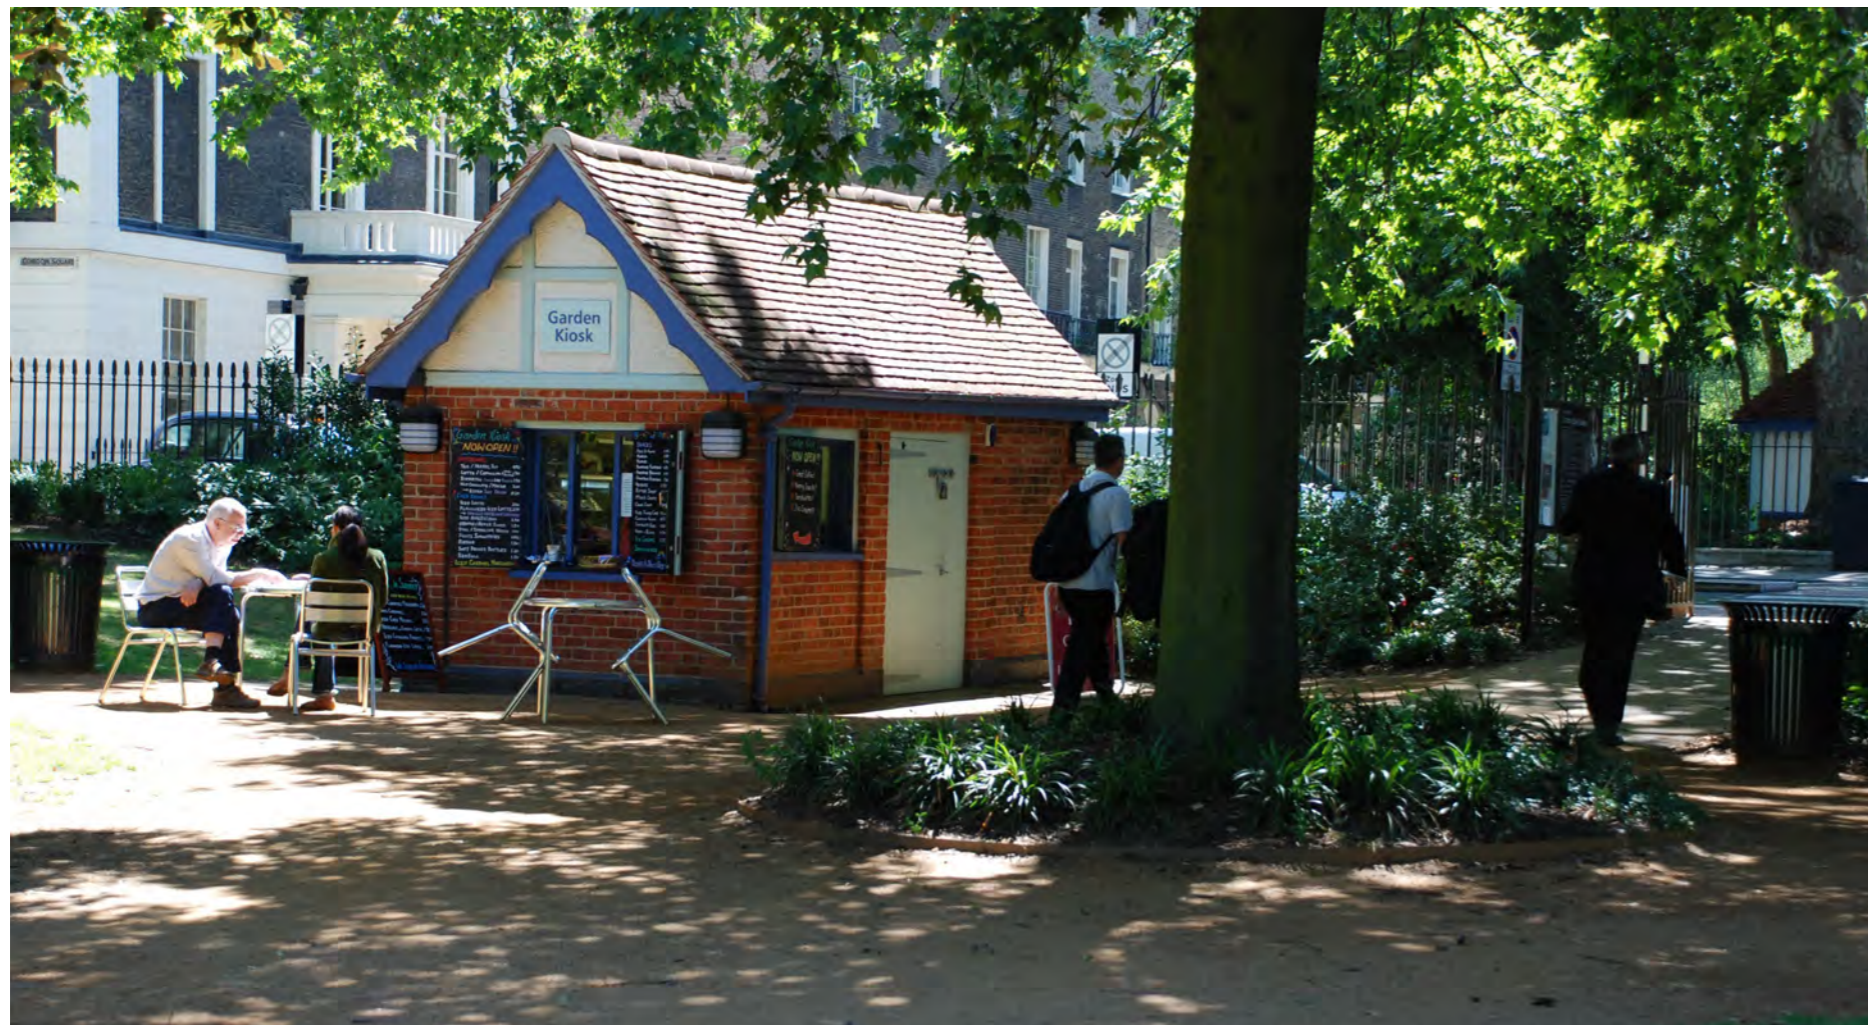
Gordon and Woburn Square Gardens form part of the extensive network of largely Georgian garden squares in Bloomsbury, although they were some of the later squares to be developed in the district.

Improving access and safety were primary concerns for the re-design of the squares. Positions of entrances were moved, as required, to best relate to pedestrian crossing points on roads and main routes. All entrances and pathways are level and easily accessible.

New facilities were also provided as part of the restoration including interpretation signage, and the small gardener's building was fitted out as a refreshment kiosk. Nearby, a section of path has been widened to form a small stage where lunchtime concerts are organised during summer.
